CALSPAN ON-SITE AIR BAG NON-DEPLOYMENT INVESTIGATION

CASE NO: CA05-049

VEHICLE: 2005 CHEVROLET COBALT

CRASH DATE: JULY 2005

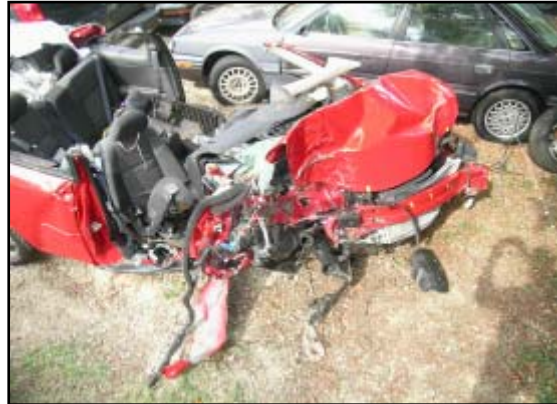
Figure 1. Subject vehicle 2005 Chevrolet Cobalt.

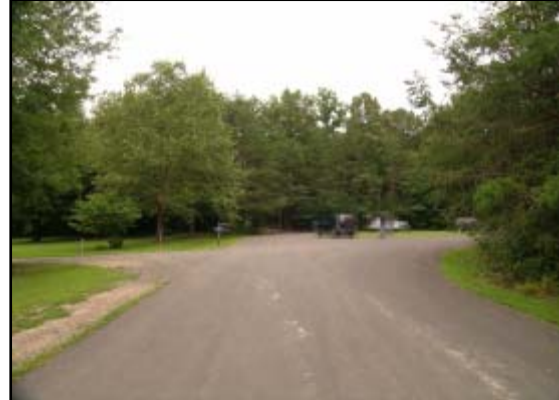
The 16-year old female driver was attending a house party at a residence located at the mouth of the cul-de-sac. She was under the influence of alcohol with a toxicology reported BAC of .17. The driver was not restrained by the manual 3-point lap and shoulder belt safety system. The lack of belt usage was determined from the vehicle inspection and EDR data. She left the party alone during the nighttime hours and attempted to exit the rural subdivision. For an unknown reason, the driver returned toward the cul-de-sac, traveling in a southerly direction on the left side of the two lane non-delineated roadway (**Figure 2**).

Figure 2. Pre-crash travel direction and overall view of the crash site.

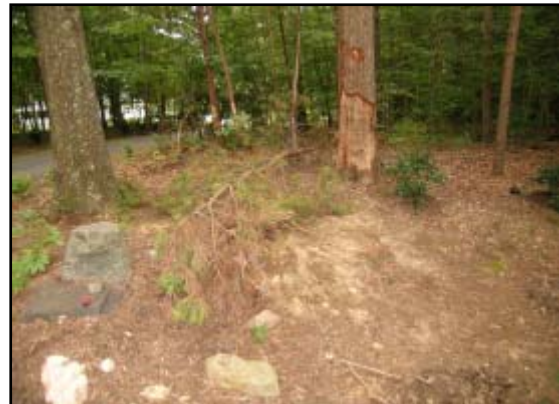
As the Cobalt traversed the mouth of the driveway, the undercarriage overrode the landscaping, which consisted of flush mounted rocks within the dirt and mulch. The front left area of the vehicle narrowly missed a large rock that was positioned vertically within the landscaped area. The Cobalt continued forward in a tracking mode and impacted a 13 cm (5") diameter pine tree with the front left area of the vehicle. The resultant direction of force for this impact event was 12 o'clock. The impact uprooted the tree, but did not fracture the 13 cm (5") trunk. The Cobalt carried the tree forward as this impact produced a minimal velocity change to the vehicle. (The delta V could not be calculated due to the masking of damage by the subsequent impact). **Figure 3** is an overall view of the crash site.

Figure 3. Overall view of the crash site.

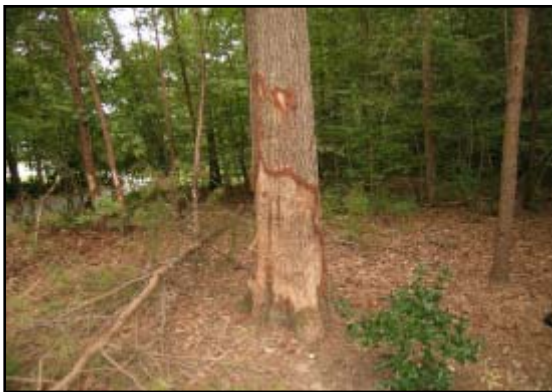
The Cobalt continued forward an additional 2.3 m where it struck a 51 cm (20") diameter hardwood tree with the front right area (**Figure 4**). At impact, the vehicle was in a near tracking attitude, and may have rotated slightly counterclockwise as a result of the initial

small diameter tree impact that was located left of center. This impact was located outboard of the right frame rail and involved the corner area of the Cobalt. The resultant direction of force was within the 12 o'clock sector. (The EDR calculated PDOF was 15 degrees).

As the front bumper beam crushed to a depth of 110 cm (43.4"), the right front tire and wheel engaged the tree. The engagement fractured the alloy wheel and axle, and front suspension components, separating the wheel and brake assembly. The crush extended onto the right side plane of the Cobalt, engaging the right A-pillar and leading edge of the right door. The damage algorithm of the WinSMASH program computed a total velocity change of 61 km/h (37.9 mph) with longitudinal and lateral components of -60 km/h (-37.3 mph) and -11 km/h (-6.8 mph) respectively. The EDR recorded a maximum velocity change of 80 km/h (49.99 mph) at 300 msec of Algorithm Enable (AE). The frontal air bag system did not deploy. Due to the offset right crash, the Cobalt began to rotate in a clockwise (CW) direction as it separated from the tree.

Figure 4. Impact with the 51 cm (20'') diameter hardwood tree.

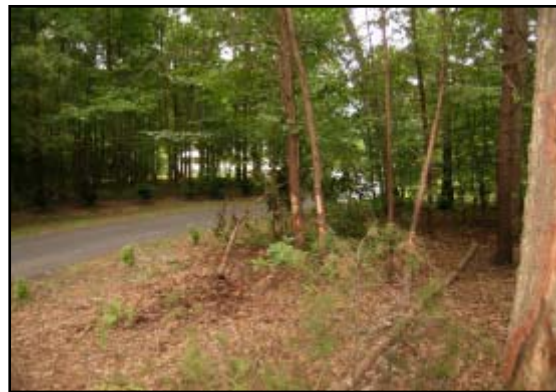
Figure 5. Area of impact with the four small diameter trees and final rest.

As the Cobalt rotated CW, the left side area impacted four small diameter trees that were located 2.8-4.6 m (9-15') south of the 51 cm (20'') diameter tree (**Figure 5**). The lateral impact deflected the trees, which resulted in a ramping effect as the undercarriage of the Cobalt rode up the trees. This ramping effect resulted in an overturn (flip-over) of the Cobalt as it rolled one-quarter turn onto its right side. The Cobalt continued to rotate approximately 40 degrees about its longitudinal axis prior to coming to rest on its side.

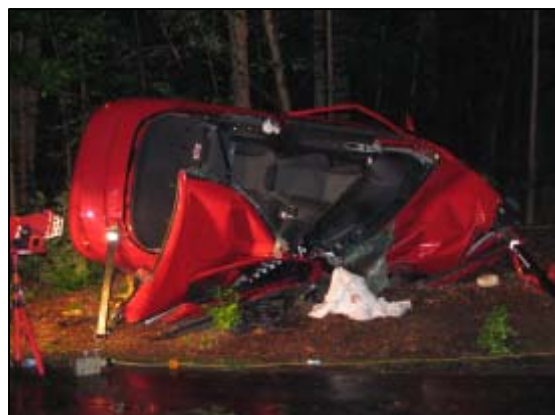
The Cobalt came to rest on its right side, facing in a northeasterly direction (**Figure 6**). At rest, the vehicle was facing in a direction that was nearly opposite of its initial travel direction. Volunteer fire

Figure 6. On-scene image of the Cobalt at final rest.

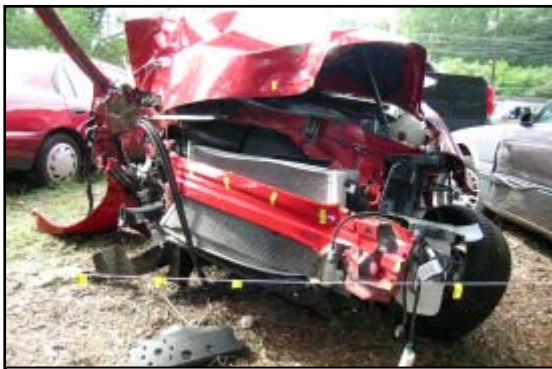
The initial impact with the 13 cm (5") diameter tree was located on the front left area of the vehicle (**Figure 7**). The direct contact damage began 29 cm (11.4") left of center and extended 11 cm (4.25") to the left. The impact dented the hood face to a maximum depth of 10 cm (4.0"). The damage and resulting crush to the bumper system was masked by the subsequent impact with the large diameter tree. The Collision Deformation

Classification for the impact was 12-FLEN-1.

Figure 7. Damage from the 13 cm (5'') tree.

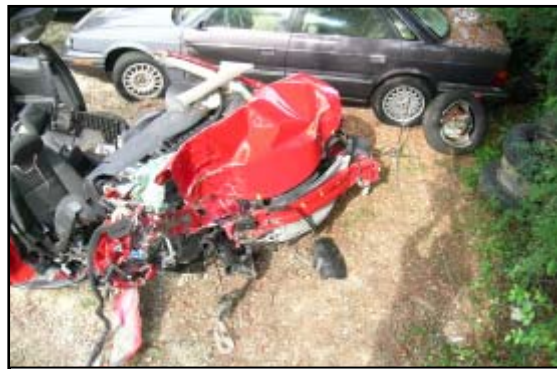
Figure 8. Overhead view of the damage from the 51 cm (20'') tree.

The Cobalt uprooted and overrode the small diameter tree as it continued 2.3 m (7.5') forward and impacted the 51 cm (20'') hardwood tree with the front right area (**Figure 8**). The direct contact damage began 41 cm (16.25'') right of center and extended 33 cm (13'') to the front right corner. The damage was concentrated outboard of the right frame rail and initially involved the corner of the bumper beam and sheet metal components. As the vehicle crushed, the right front tire/wheel and axle assembly engaged the tree followed by the right A-pillar area. The right corner impact deformed the full width of the frontal structure. The combined induced and direct contact damage at the bumper level measured 67 cm (26.5''), extending from corner-to-corner of the bumper beam. Maximum crush was measured at 110 cm (43.4''), located at the front right corner of the bumper beam. The crush profile at the level of the bumper beam was as follows: C1 = 12

cm (7.6"), C2 = 48 cm (18.75"), C3 = 56 cm (21.9"), C4 = 67 cm (26.5"), C5 = 80 cm (31.4"), C6 = 110 cm (43.4").

As the Cobalt continued forward and began to rotate in a clockwise direction, the right front tire and wheel engaged the tree. This contact fractured the inner aspect of the alloy wheel rim and fractured the right front axle and suspension. The tire/wheel and brake assembly separated from the Cobalt. The right A-pillar engaged the tree and crushed the base of the pillar approximately 67 cm (26.5") rearward. (It should be noted that the investigating officer stated that this area of the vehicle was pulled forward using hydraulic equipment as the officer interrogated the vehicle in search of the air bag control module.) The welded section of the right A-pillar, toe/floor pan, and the right sill separated due to the extensive crush and induced deformation. The CDC for this event was 12-FREE-7.

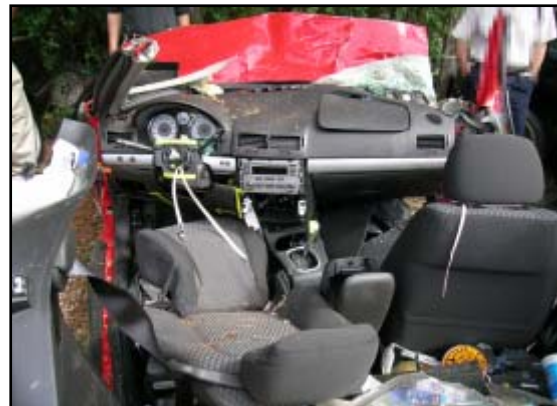
The steering wheel rotated upward as the cowl of the vehicle intruded rearward. The driver's abdominal region loaded the lower aspect of the steering wheel rim. Her loading force fractured the mounting flange of the alloy wheel, thus resulting in complete separation of the steering wheel and air bag module from the column. This assembly was not with the vehicle at the time of the SCI inspection. The separated steering wheel was noted in an on-scene police image of the crash site. In addition to the flange fracture, the driver compressed the energy absorbing steering column as evidenced by 0.6 cm (0.25") of left shear capsule separation and 2 cm (0.75") of right capsule compression. **Figure 9** is overall view of the driver's trajectory and contact points.

Figure 9. Driver trajectory and contact points.

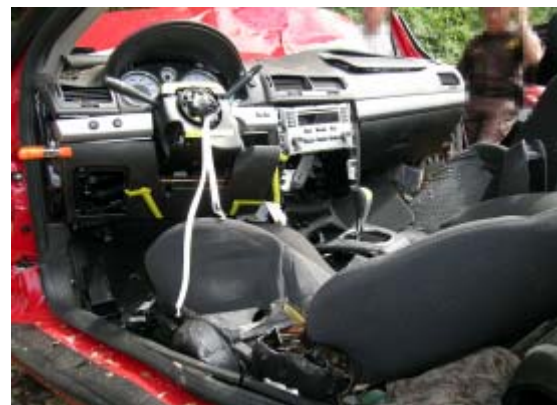
The driver's knees and lower legs impacted the knee bolster (**Figure 10**). Her left knee scuffed the bolster 15-22 cm (5.75-8.75") inboard of the left edge of the bolster panel and 15-23 cm (5.75-9.25") below the top edge of the plastic panel. The right knee contact was located 44-50 cm (17.25-19.75") inboard of the left edge and 20-24 cm (8-9.5") below the top edge. A fabric scuff from her right leg was noted to the left side of the mid instrument panel at its juncture with the center console. This triangular fabric transfer was 13 cm (5") in

Figure 10. Driver contact to the knee bolster.

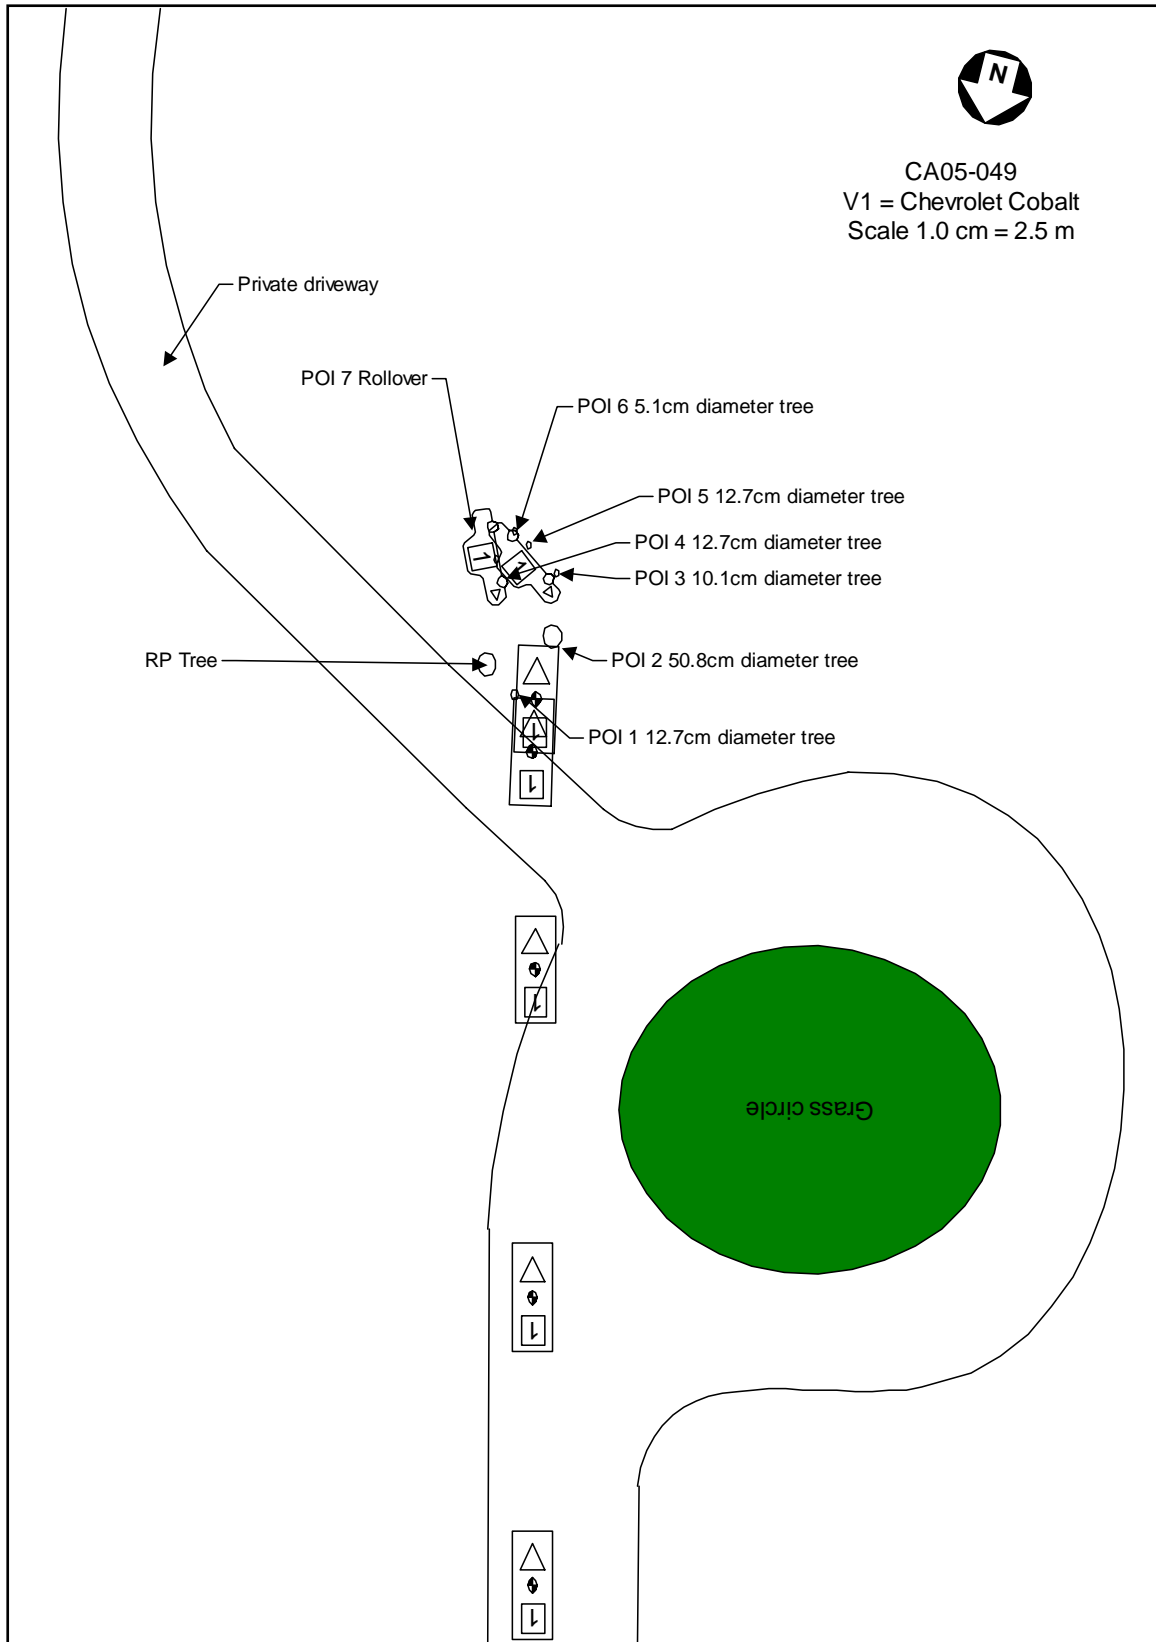
Figure 11: Scene Schematic

The crash occurred in a remote, rural residential area at the end of a cul-de-sac roadway during dark, nighttime hours. At the time of the crash, the weather conditions were police reported as overcast with wet environmental surfaces from a previous rainfall. A two-lane asphalt surfaced roadway terminated at a 29.8 m (98') diameter cul-de-sac, which formed a circular loop to the right of the approach roadway. The roadway was 6.4 m (21') in width and was bordered by grass/vegetation with no stabilized shoulders. A 17 m (55.8') diameter grass circle was centered within the cul-de-sac. The posted speed limit for the area was 40 km/h (25 mph). There were no lane lines or edge line markings on the road. A residential driveway intersected the cul-de-sac at the top, left aspect of the circle, with respect to vehicle travel. Numerous trees and a rock-landscaped area bordered the edges of the driveway and the cul-de-sac. At the crash site, the initial impact involved a 13 cm (5") diameter (soft wood) tree, a 51 cm (20") diameter oak tree, and four small trees that ranged in diameters of 5-13 cm (2-5"). The scene schematic is included as **Figure 11**.

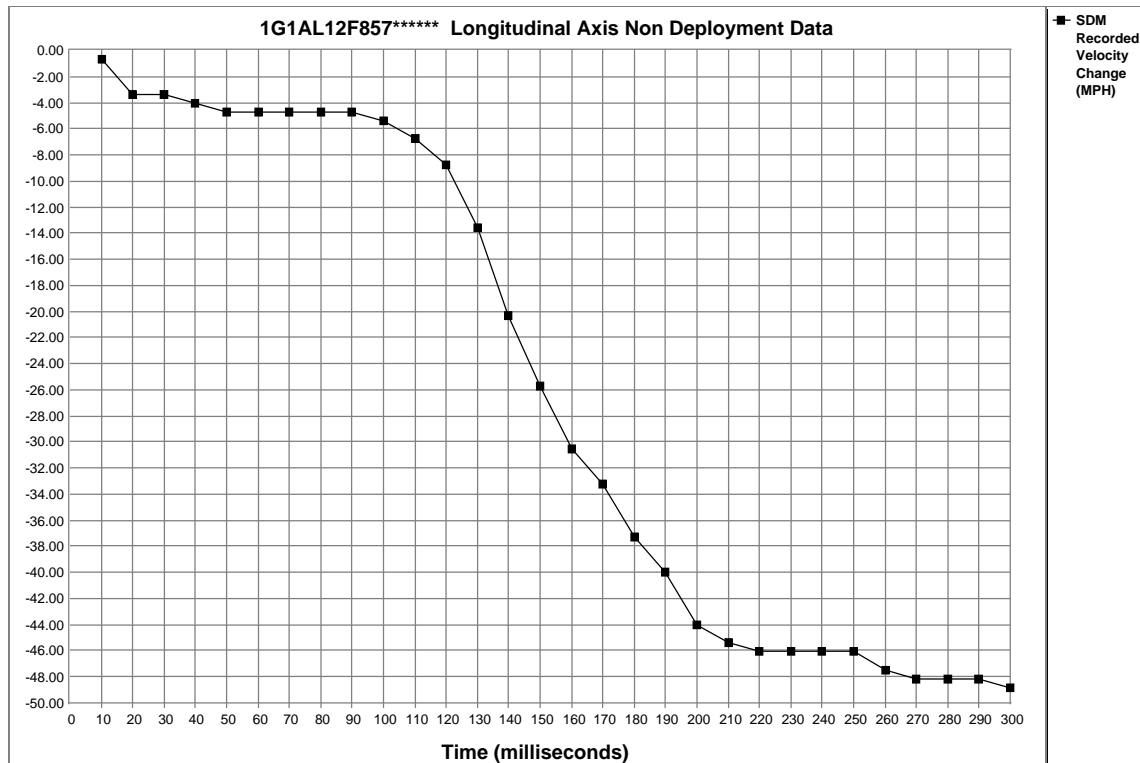
Time (milliseconds)	10	20	30	40	50	60	70	80	90	100	110	120	130	140	150
Longitudinal Axis Recorded Velocity	-0.68	-3.39	-3.39	-4.07	-4.74	-4.74	-4.74	-4.74	-4.74	-5.42	-6.78	-8.81	-13.56	-20.34	-25.76
Time (milliseconds)	160	170	180	190	200	210	220	230	240	250	260	270	280	290	300
Longitudinal Axis Recorded Velocity	-30.50	-33.21	-37.28	-39.99	-44.06	-45.42	-46.09	-46.09	-46.09	-46.09	-47.45	-48.13	-48.13	-48.13	-48.80

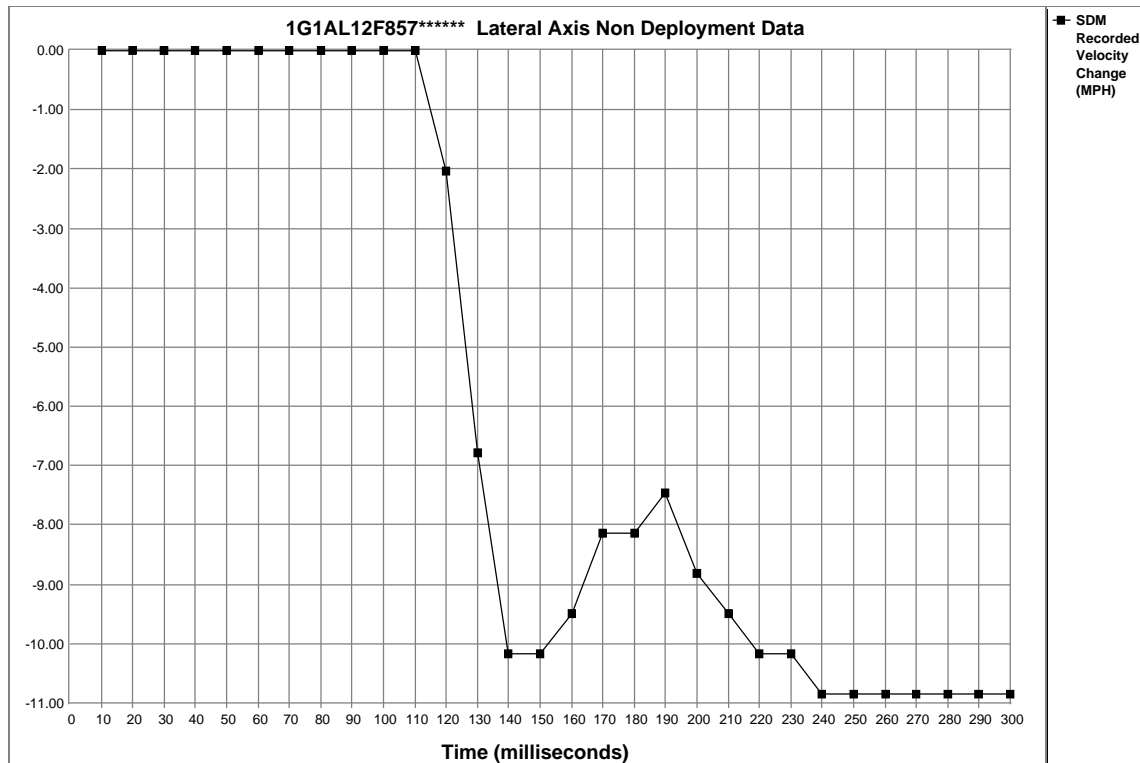
Time (milliseconds)	10	20	30	40	50	60	70	80	90	100	110	120	130	140	150
Lateral Axis Recorded Velocity Change (MPH)	0.00	0.00	0.00	0.00	0.00	0.00	0.00	0.00	0.00	0.00	0.00	-2.03	-6.78	-10.17	-10.17
Time (milliseconds)	160	170	180	190	200	210	220	230	240	250	260	270	280	290	300
Lateral Axis Recorded Velocity Change (MPH)	-9.49	-8.13	-8.13	-7.46	-8.81	-9.49	-10.17	-10.17	-10.85	-10.85	-10.85	-10.85	-10.85	-10.85	-10.85
